# Manhole Inspection Summary

Manhole # S19I1\_027MH

Insp Date: **6/17/09 12:35 PM**

**Location** Address: **2907 HURON ST**

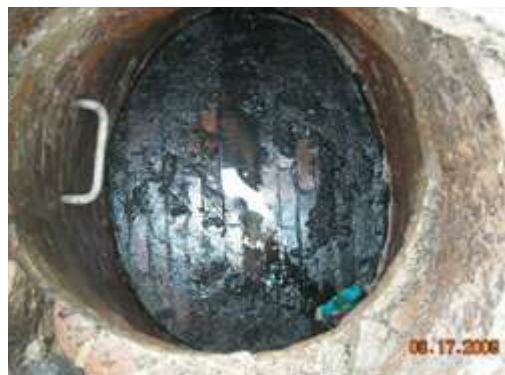
Top View

Comments **CLEANED MANHOLE TO COMPLETE INSPECTION**

POST CLEANING

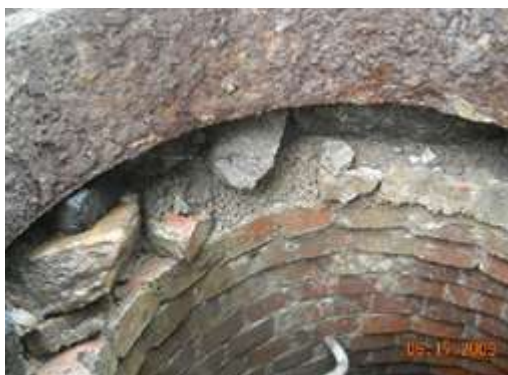
Defect 3

Condition: ☐ Sound ☐ Cracked ☐ Root Intrusion ☒ **Loose Brick** ☒ **Deteriorated**

DETERIORATED CHIMNEY BRICKS

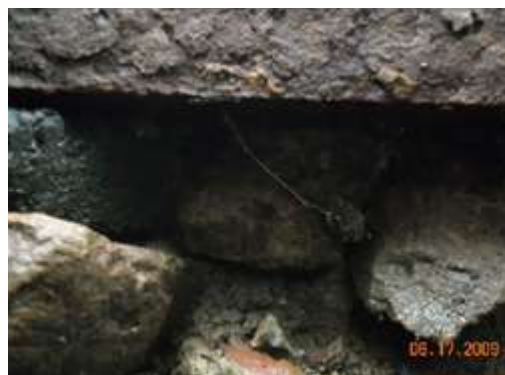
Defect 2

LOOSE/MISSING CHIMNEY BRICKS

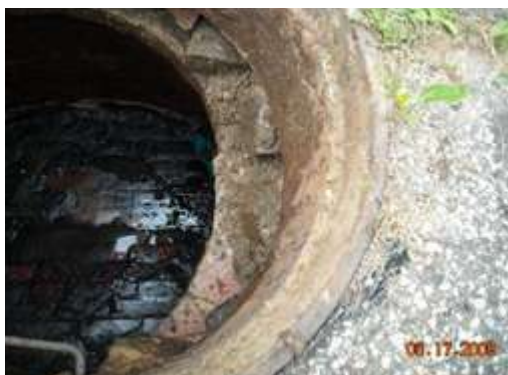
Defect 1

**Frame** Offset: **3** (in.) Condition: ☒ Sound ☐ Cracked ☐ Leaks

FRAME OFFSET

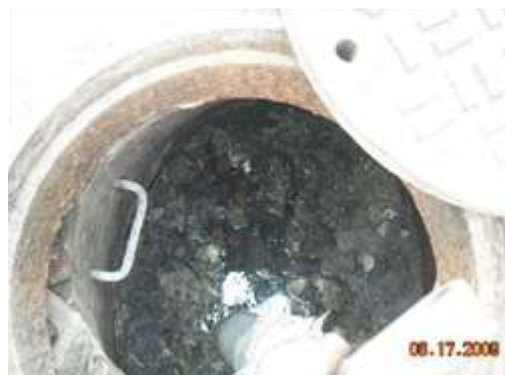
Defect 4

**Surcharge** ☒ **Evidence Of Surcharge** Depth: **2** (ft.) ☐ Active Surcharge Present

evidence od surcharge, removed by  
Vactor

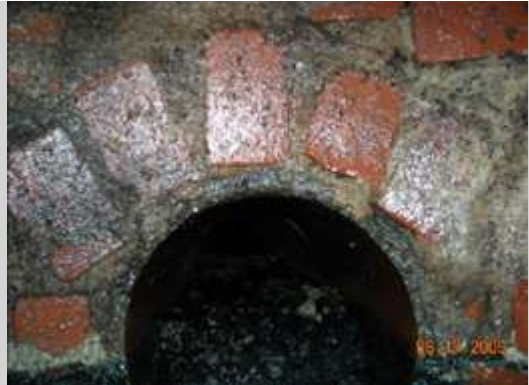
12 O'Clock Outflow

8 in. Circular Gravity Sewer  
Pipe Out @ 12 O'Clock

Pipe Height: **8.4** (in.) Rod and Bar (Angled)  
Pipe Material: **Clay** ☐ Pipe Lined  
Invert Depth: **5.55** (ft.) Flow Characteristics: **Slow**  
Deposits: ☒ None ☐ Mud ☐ Sludge ☐ Debris ☐ Grease  
Silt Depth: **0** (in.) Deposits Extent:  
Infiltration: **None** Pipe Seal Cond: **Sound**

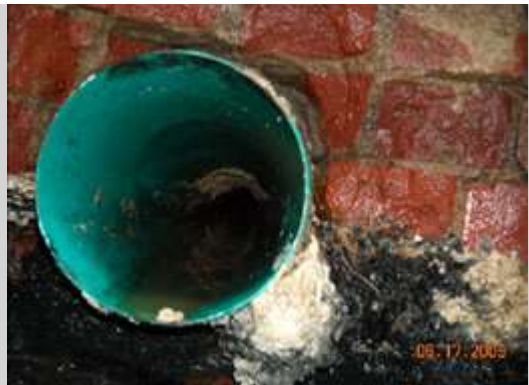
5 O'Clock Inflow

6 in. Circular Gravity Sewer  
Pipe In @ 5 O'Clock

Pipe Height: **6** (in.) Rod and Bar (Angled)  
Pipe Material: **PVC** ☐ Pipe Lined  
Invert Depth: **5.40** (ft.) Flow Characteristics: **Slow**  
Deposits: ☒ None ☐ Mud ☐ Sludge ☐ Debris ☐ Grease  
Silt Depth: **0** (in.) Deposits Extent:  
Infiltration: **None** Pipe Seal Cond: **Sound**
